FINAL REPORT

ACCIDENT DESCRIPTION

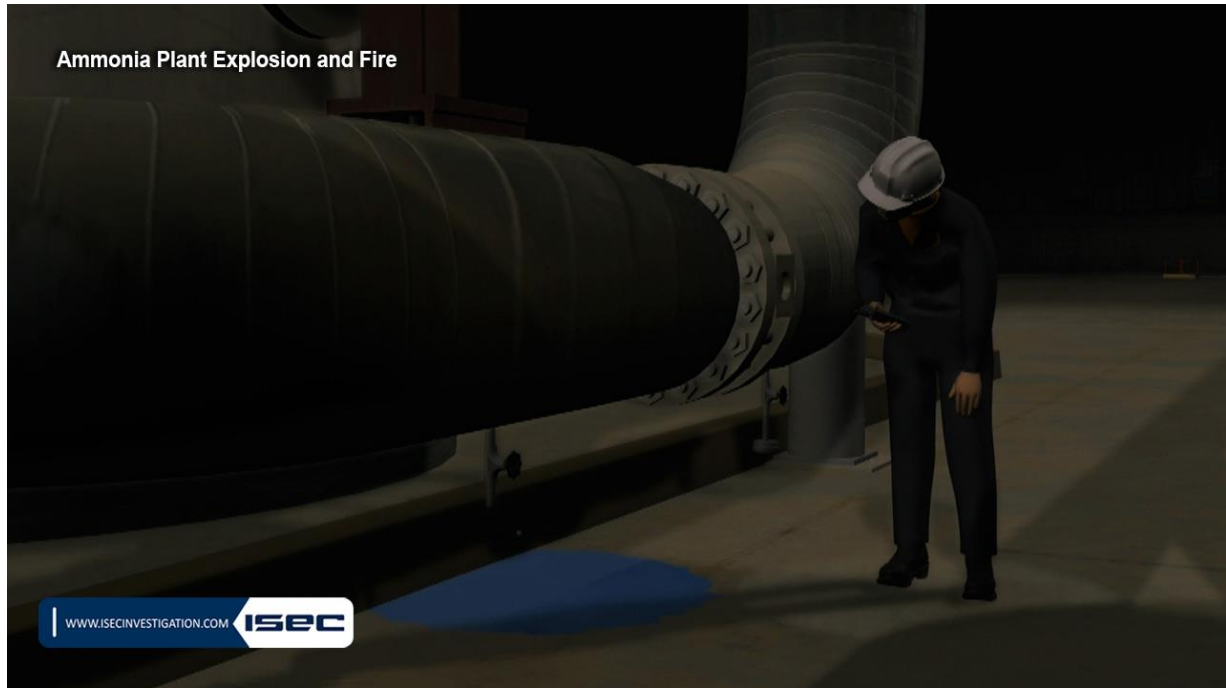
Two days before the accident, the unit was put in service once again after the packing of the CO₂ stripper replaced. The night before the accident, a leakage was observed in 32-inch semi-lean amine pipeline near the FV-2004 control valve.

Figure 1. Leakage in 32-inch semi-lean amine pipeline

After welding the cone, workers noticed an increase in the leakage. After that, it was decided to make a larger cone to be installed instead of the first one. At 13:57, the fitter together with his hand began separating the first cone but suddenly the severity of leakage increased. Site operator present at the scene reported the accident to the control room when he saw the great increase in leakage. Fitters and then the operator

decided to leave the place and run to the site fence as they see an increase in leakage and pipe shaking. The pipeline suddenly ruptured and Amine with the pressure of 38bar came out of the rupture spot in a way that the fluid spread in a range of 60 meters and hit the people who were present at the scene.

A plate or a cone (nipple) welded on the pipeline can inhibit the leakage without unit shutdown, when there is a minor leakage in the pipeline and its content has no possible risk of fire and explosion. According to standard API RP 2201, welding or hot tapping should not be performed on pipes containing amines. Welding or hot tapping on pipes containing amines, acids, and bases may cause cracking in the weld area or heat affected zone.

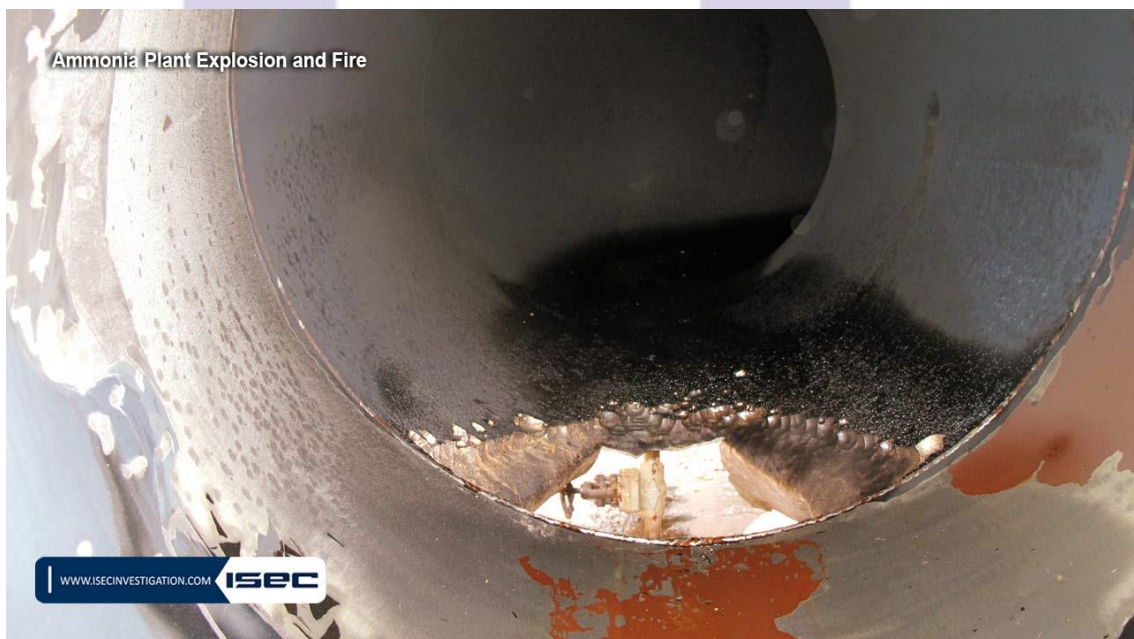
- Rupture spot, which is along the weld line converter, made from stainless steel and the pipe made from carbon steel, which also extended along the pipe. With regard to the previous corrosion of carbon steel packing in disposal tower, designer`s comment on this fact and evidence of corrosion at the scene of the accident, corrosion factor of wet CO₂ is the main cause of this rupture.

Figure 2. Corrosion factor of wet CO₂

- In the processing units, repair work on piping or equipment in service should be done according to the API-RP 2201 and API2009 standards and a written plan should be prepared for each activity. One of the major standard requirements in such cases is measurement of thickness and careful evaluation of corrosion.

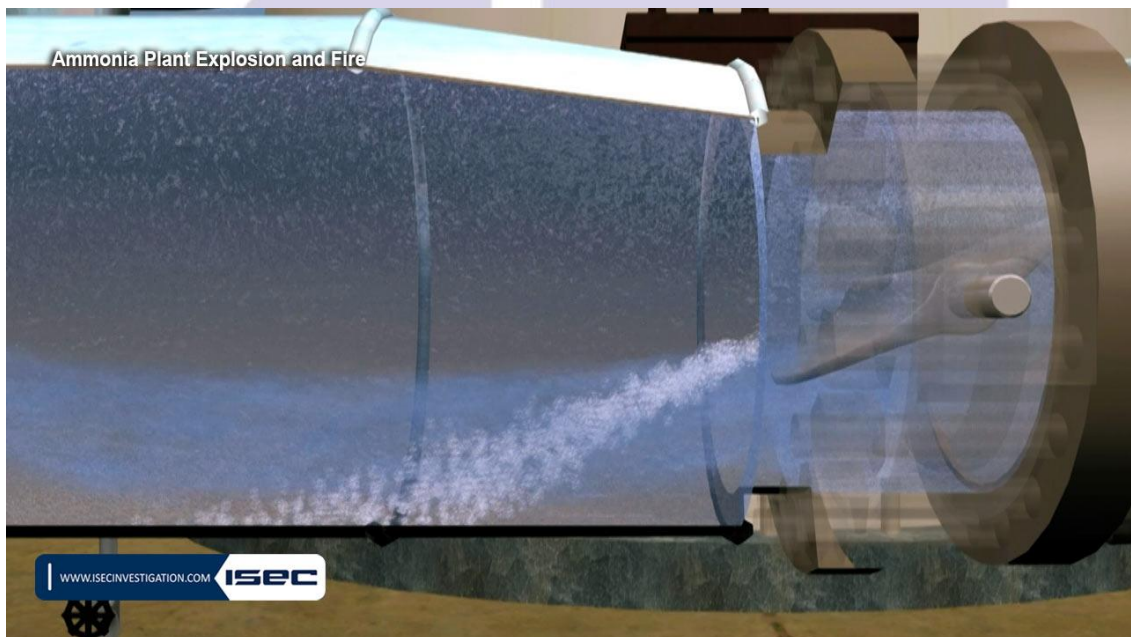
- The FV-2004 control valve was a butterfly valve, which passed the flow completely when adjusted on 60%. This caused the flow to hit the lower part of the pipeline and it led to corrosion and more importantly cavitation in that spot. In general, all above-mentioned factors caused a decrease in the thickness of pipe at the rupture spot from 19.6 to 3 mm while API-RP2201 standard recommends a minimum thickness of 4.8 mm required for welding on the lines which are being serviced.

Figure 3. The FV-2004 control valve adjusted on 60%

- It is recommended to install a check valve in the entrance of absorber to prevent future accidents in ammonia units.
- Hazop study or its update for the processing units based on HSE-321-07 guide is obligatory. In such studies, it is necessary to pay special attention to fluctuations in processing factors such as temperature, pressure, flow, etc. which may cause fire and explosion.
