# ***FINAL REPORT***

## ***ACCIDENT DESCRIPTION***

## **ACCIDENT DESCRIPTION**

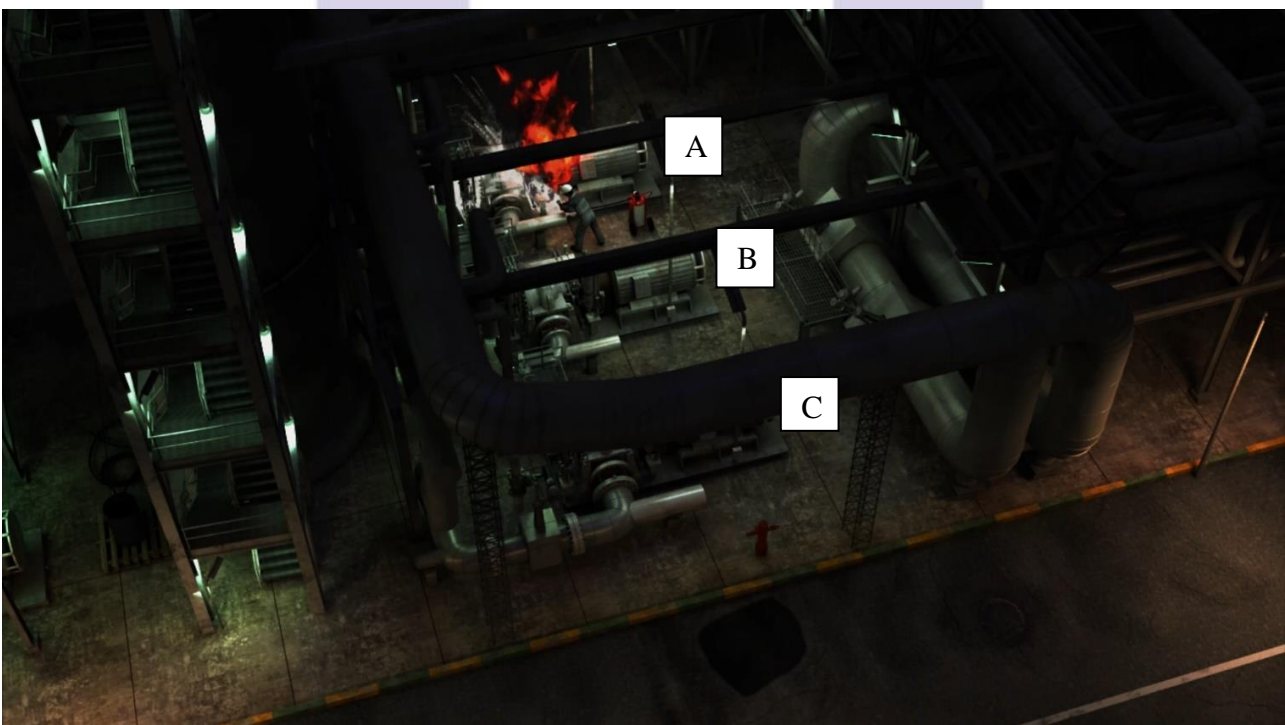
In this petrochemical complex, 3 pumps 8001A/B/C are used to transfer the paraxylene liquid to the aromatic tower. The temperature of the paraxylene liquid after the pump is about 300 degrees Celsius and its pressure is 10 bar. The suction and discharge valves of these pumps are 32- and 20-inches manual, and for moving the thread up and down, the handwheel of the gearbox must be turned about 24 times. For this reason, a long time ago, it was decided to use an electric motor gearbox to open and close each valve. But the electric gearbox, while being more expensive, became defective after some time of use and was no longer able to close the valves completely. Therefore, to move the last threads, the operators removed the electric motor gearbox and installed a manual gearbox on each valve. In this way, four manual gearboxes and two electric motor gearboxes were installed on these pumps. For isolation each pump, at first the electric motor gearbox should be installed on the relevant valve and after closing the valve, the electric motor gearbox was removed and then the manual gearbox was installed to completely close the valve.
