FINAL REPORT

ACCIDENT DESCRIPTION

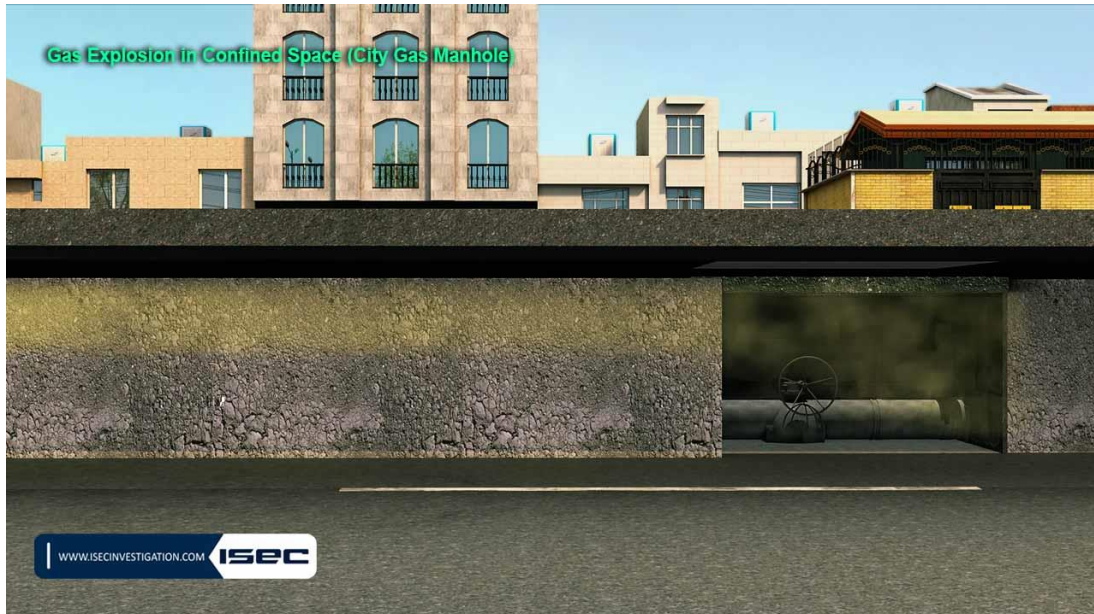
The investigation revealed a 6-inch valve of the 60psi gas network within 14m of the manhole, which had been buried due to civil works. After excavations, the valve spindle had been found severely damaged due to collision with civil construction machinery, which led to gas leakage.

The leaked gas had entered the manhole from under the road asphalt layer and trapped there until reached its explosion concentration due to blocked ventilation opening.

Figure 1. The gas leak entered the gas manhole from under the asphalt layer

According to the regulations, confined space permit for every entry and hot work permits, each requires gas testing. If they had done gas testing, could have prevented this accident and the unfortunate fatality.
