# ***FINAL REPORT***

## **ACCIDENT DESCRIPTION**

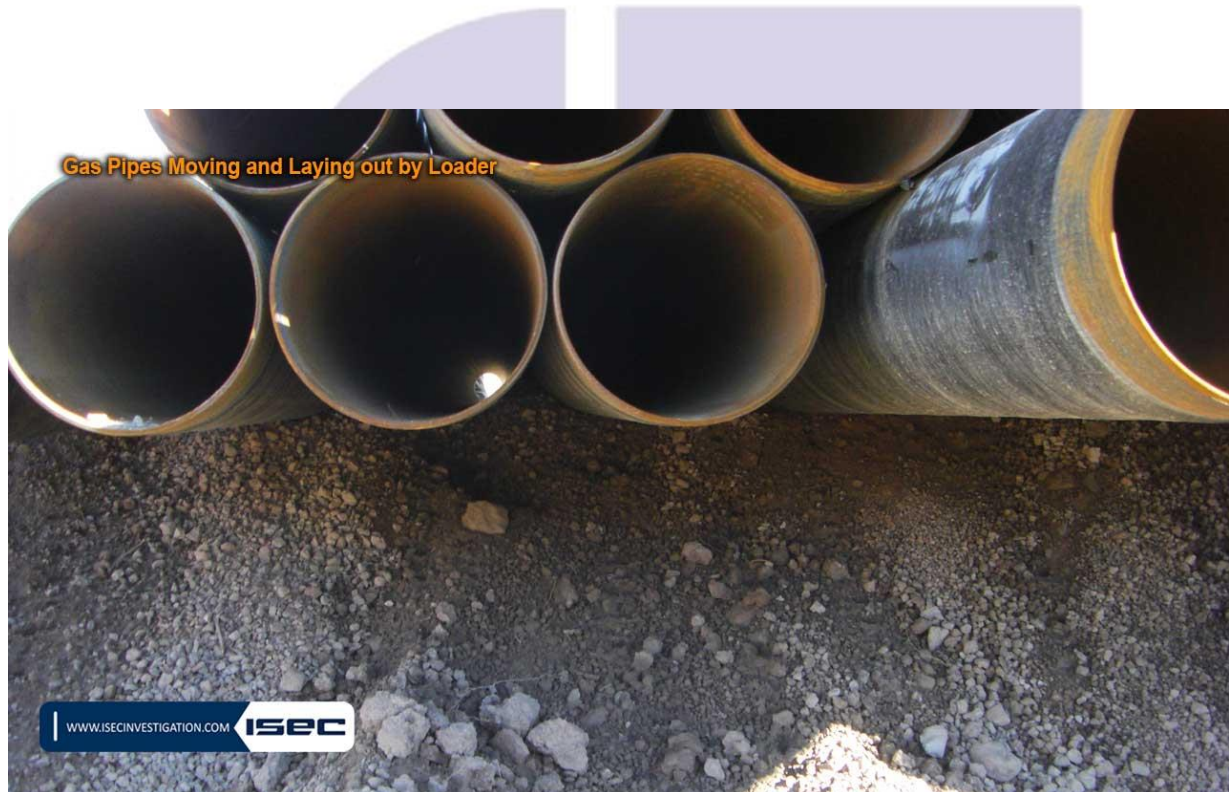
- Gas pipes must be laid out and moved by a crane or side boom with the considering safety precautions and presence of a guide. Loader, excavator, forklift and etc. should never be used for this purpose.
- Taken images after the accident show the pipes were not stacked on the top of each other regularly and no restraints were used to hold the pipes in place. Since smoothing and reshaping under the pipes was not made properly, the surface was not smooth and therefore it was not possible to arrange the pipes.

**Figure 1.** Smoothing and reshaping under the pipes was not made properly
