FINAL REPORT

Accident Occurred On: 09/13/2010

INCIDENT DESCRIPTION

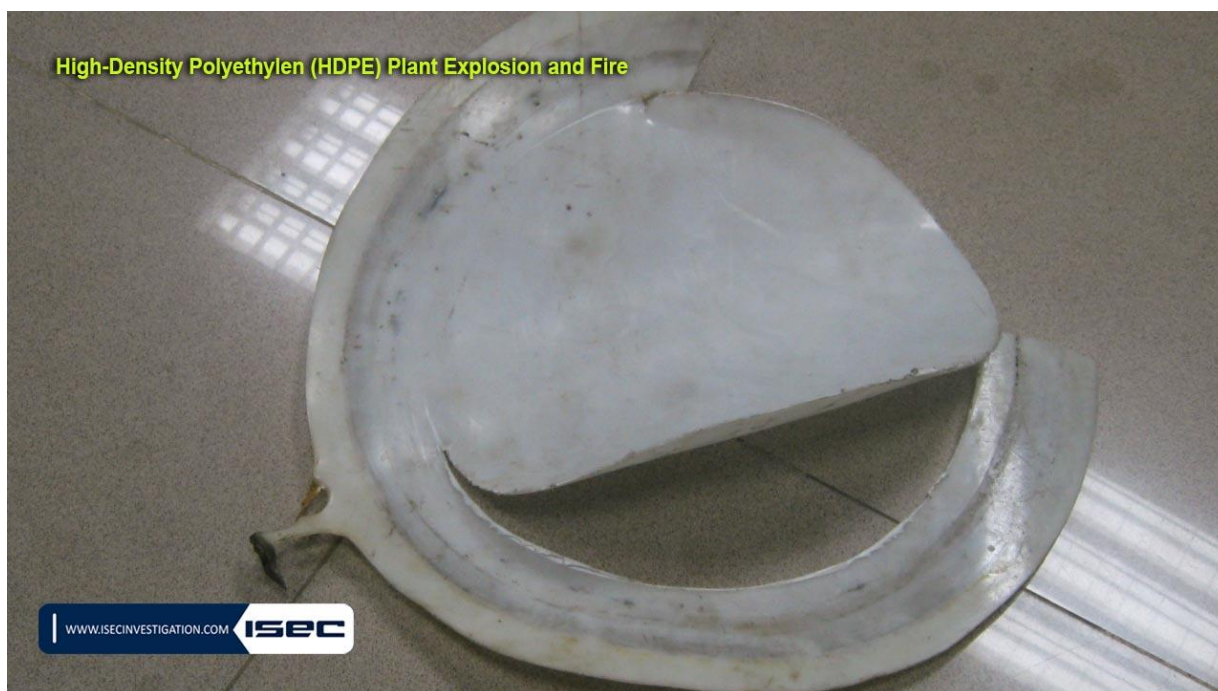
The HDPE unit has a section in which equipment and pipes have interior glass wall. For isolating the flanges, two Teflon spades are inserted on both side of a steel spade flange. On the day of accident, the person who was inserting the spades between the relevant flanges used only one Teflon spade flange instead of two. Maybe because of

much more weight of the steel type, he didn't insert the steel spade into flange. However, the Teflon spades flange were just allowed to be used in a certain part of the unit simultaneously by steel one.

Figure 1. Teflon spade flange instead of steel type

The unit operator did not monitor the performance of the person properly. Since the handle of spade flange was placed incorrectly upwards; therefore, the unit operator couldn't realize that the spade flange was of Teflon type.

The reactor pressure was high and resulted the hexane flowing into this pipe and accumulated behind the Teflon spade flange. The hexane solvent with a pressure more than 4.5 bar ruptured the Teflon plate and flowed to the blower and then to the condenser and finally reached to the disconnected point in the pipeline.

- A pre-startup safety review (PSSR) should be implemented in the operating units, before initial commissioning, whenever the unit has been out of service for a long time, or when major changes are occurred.
- Following up exactly the procedure for process valve insulation.
- Avoiding unnecessary project activities at the time of startup.
- Use of experienced and skilled contractors for maintenance activities.
- Improving the level of discipline among units through exchange of information between shifts, the careful monitoring of the activities carried out on the site especially in sensitive times such as startup as one of the principles of PSM safety management.
