FINAL REPORT

At 14:29 on 2nd February 2011, an explosion happened at NF2 propane sweetening unit in a petrochemical complex. Unfortunately, in this accident 17 workers were injured by the blast radius and two people lost their lives because of serious injuries.

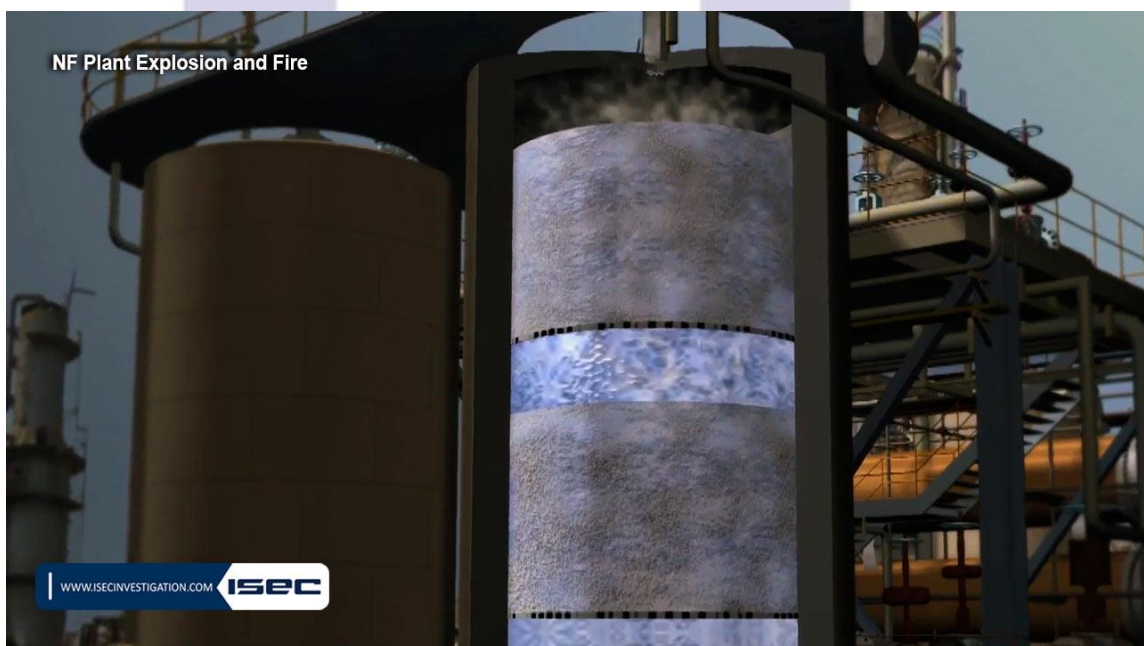
Figure 1. Formation of gas hydrate

- In this plant, coincided with furnace maintenance and subsequent inability to carry out the restoring operation, liquid collector tank was put out of service and it was made blind. Although at the time of removal from service, repairing activities were finished and the tank could be in service, unit operators supposed that replacing two very important steps of fluid drain and drying absorption beds with an almost long-term nitrogen purge, can strip the absorption beds from liquids and hydrocarbon gases. But what was not predictable was the formation of gas hydrate. With the starting of putting the unit out of service, liquid propane was not drained because the liquid collector tank was blind. The propane began to evaporate and the tower temperature reduced to below 0 ° C. Since this tower was in service for two weeks without any restoration operation, the molecular sieve substrates and silica gel were saturated with water or at least were nearly saturated with water. Because of the temperature below zero and the positive pressure in the tower and the water in the substrates the gas hydrate was formed. Gas hydrates are like ice crystals and the water in hydrate could store propane 160 times its volume. The injecting nitrogen with the environment temperature created some channels in the mass and removed large amounts of propane during two days. Of course the nitrogen pressure was about 6 times and it has been a factor in hydrate stability. If the hydrate was not formed all the propane could be evaporated and purged to the flare with the nitrogen. But within a few hours on the day of the

accident while the nitrogen purge was interrupted, adsorbent beds in which liquid propane was frozen began to melt and at first the u-shaped part of the tube at the bottom of the tower was filled. While the volume of liquid increased, its vapor filled the space inside the tower and due to the higher air temperature in the middle of the day, the tower pressure increased rapidly. Unfortunately vent route on the top of the tower was not opened because of unknown reasons possibly forgetfulness or a lack of attention. The pressure inside the power increased and as a result it moved up in the pipe. The accumulated liquid slowly leaves the valve flange and the pressure inside the tower goes up gradually and the height of liquid column is reduced and thus the outflow of liquid increased. In fact, the evaporation of liquid inside the absorbents caused pressure on the top of the tower, and since there was no way for the gas to go out, it pushed the accumulated fluid in the pipe toward the valve which was being replaced, and eventually, a fatal accident happened due to a lack of change management principles.

- Different steps of a service operation must be done carefully and completely. In case one step cannot be carried out, all aspects should be considered to remove it. In fact, change management should be considered in the operational plants, and solutions and guidelines based on personal experience should also be avoided. Especially if the changes are related to the process unit, as this accident, process engineering have important role in managing the change.

- Any stop and restart of the Units should be done in accordance with safe operating procedures (SOP) and every change at any stage of work due to operational problems must be accomplished along with the prediction and risk assessment procedures.
