FINAL REPORT

INCIDENT DESCRIPTION

CAUSES OF THE INCIDENT

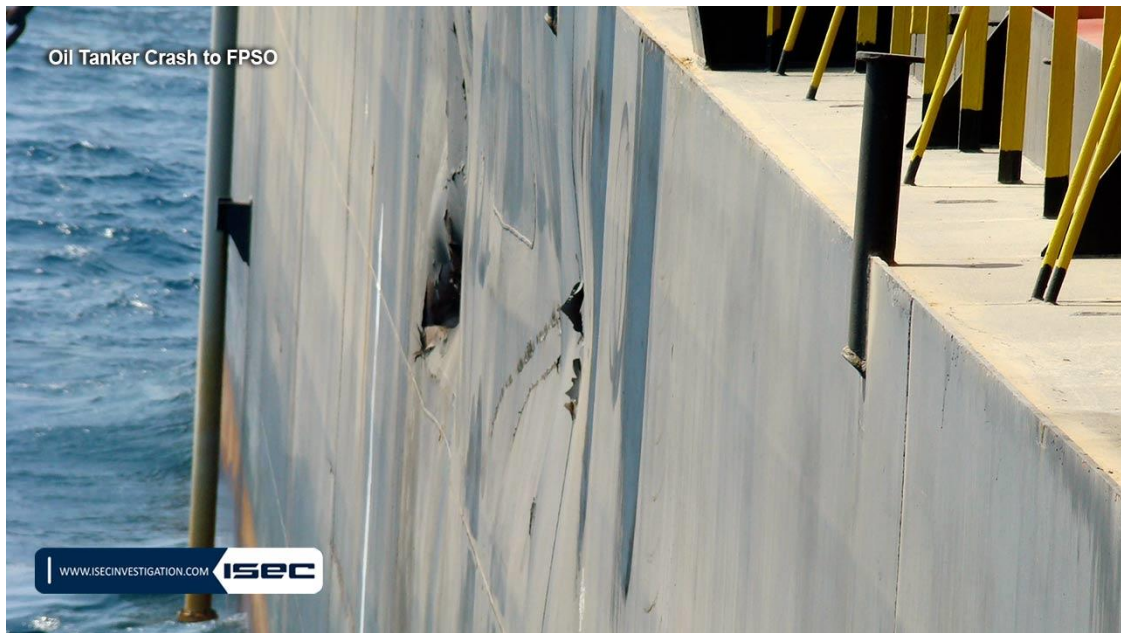
Unfortunately, the process of unlocking tandem from control room failed due to the lack of necessary training and practice, so they had to go to the AFT station panel to press emergency release push bottom or manual release by hydraulic oil pump. At 2:56 FPSO Cyrus crew gathered in Starboard Muster Station and were waiting for the command to leave the tanker. During the third maneuver, the Rope of Karen 6 was torn and it caused the tanker port Anchor touched the portside FPSO hull for the second time at 3:02, so it slightly damaged the FPSO Cyrus. During the last maneuver, the pilot directed the tanker to sail forward so that its Stern moves to the right. Suddenly tandem separated from FPSO Cyrus and tanker bow started to rotate rapidly sailing toward FPSO Cyrus. It was at 3:11 that the third collision occurred between the tanker port Anchor and FPSO Cyrus hull.

As a result, a hole of several meters in diameter occurred in the exterior wall of balancing water tank. The pilot gradually retracted the tanker and cleared off FPSO Cyrus, in the meanwhile, the cargo hose was still hung on tanker crane hook. The export hose broke on FPSO Cyrus side, fell into the water and sank. After a while, the tanker crew noticed that hose wasn't connected to Cyrus anymore and it was only connected to the tanker crane. Knowing this, the pilot moved the tanker away from Cyrus terminal. According to CCTV cameras, before the tandem fell, it had collided with the export hose resulting in end spool rupture of the export pipeline.

Figure 1. 5-meter hole on vessel hull

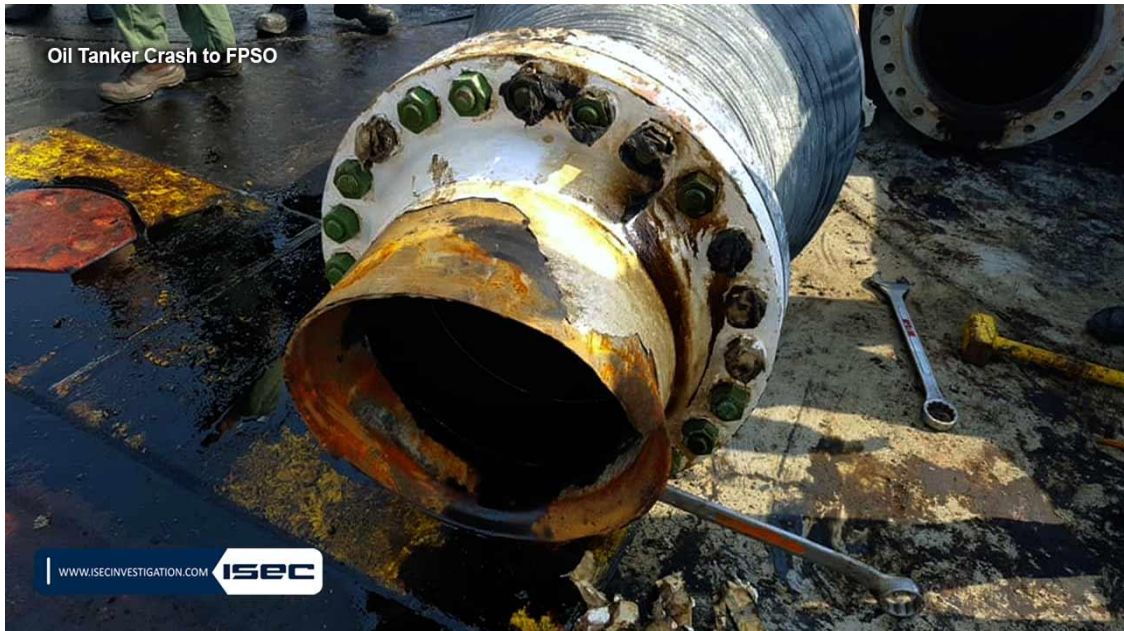
As a result, about 230 oil barrels leaked into the sea. Then, the contaminated area by the oil spill was cleaned up at 3:25 by applying OSE using ERA Indonesia vessel.

They had no clue of the fact that this release shall be performed as the tanker is sailing backwards. After disconnection, tandem collided with the export hose which resulted in a spool damage above the flange connect to the hose. Half of spool pipe was cut but it wasn't fully separated. As the tandem was released, the tanker could sail backwards. A few minutes later, the 300-meter-export hose, still connected to the tanker crane, was pulled and then with the connected flange was separated from the broken part of spool and dropped in the water and it was all before the operation of marine breakable coupling MBC. Unlike the initial presupposition, if tandem had urgently released in the first moments of 40 degrees deviation and they had not waited for the quick release of export hose, MBC would have had a stretch of 60 tons and operated as the tanker was sailing back. Therefore, no damage or loss would have occurred. The applied spool was 20 schedule thick; while according to the standards design, it should be 80. Fortunately, as tandem was released, a crew member of FPSO courageously pushed the total shutdown bottom so that the collision got under the control and a serious accident was prevented in

Figure 2. spool pipe
