# ***FINAL REPORT***

## ***ACCIDENT DESCRIPTION***

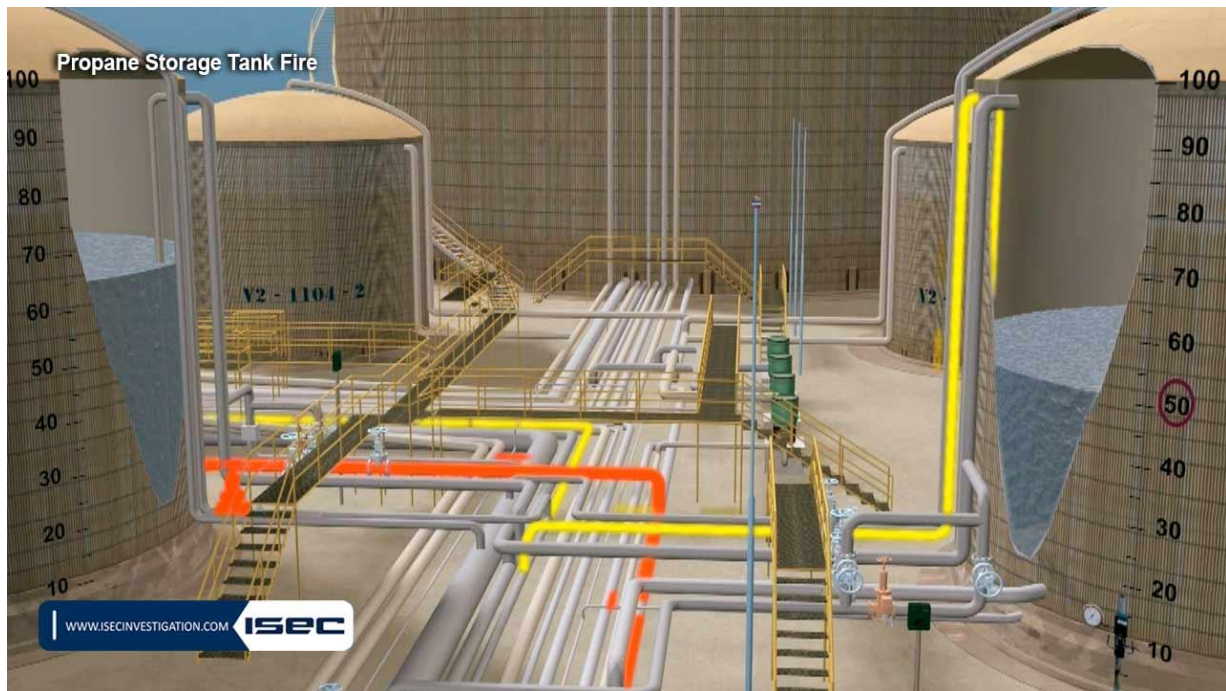
**Figure 1.** Operation group begins transferring propane from the daily tank to the main reservoir
