FINAL REPORT

ACCIDENT DESCRIPTION

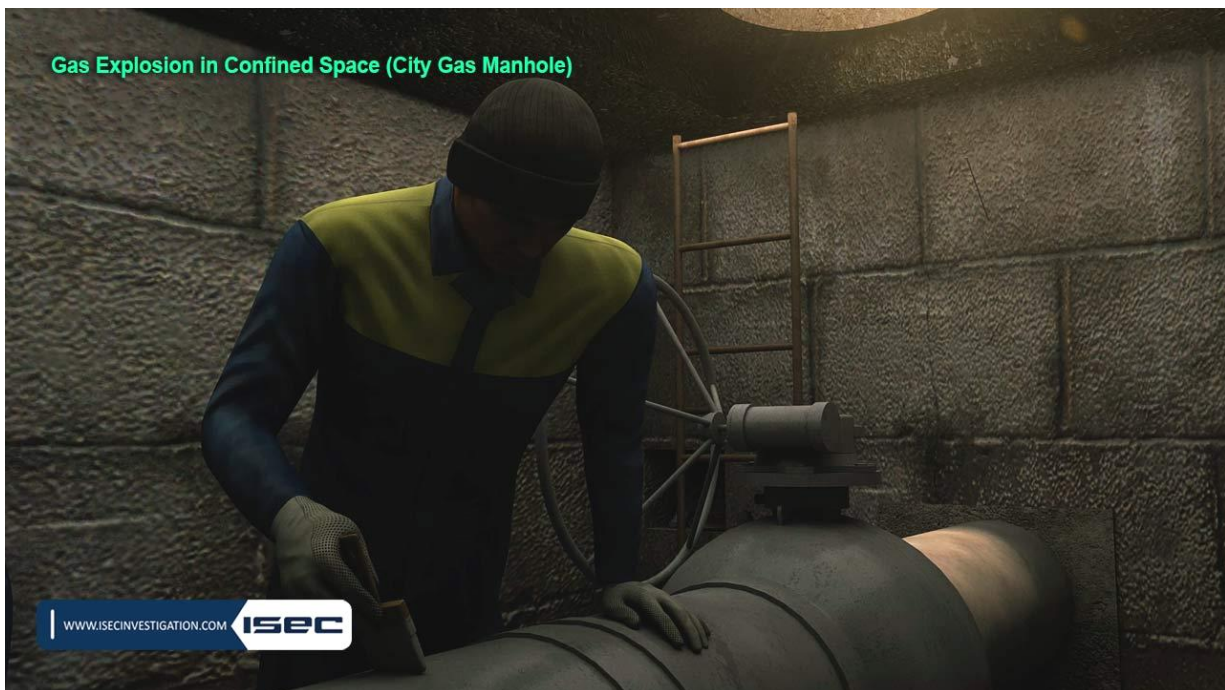
The investigation revealed a 6-inch valve of the 60psi gas network within 14m of the manhole, which had been buried due to civil works. After excavations, the valve spindle had been found severely damaged due to collision with civil construction machinery, which led to gas leakage.

The leaked gas had entered the manhole from under the road asphalt layer and trapped there until reached its explosion concentration due to blocked ventilation opening.

Figure 1. The gas leak entered the gas manhole from under the asphalt layer
