# ***FINAL REPORT***

## **ACCIDENT DESCRIPTION**

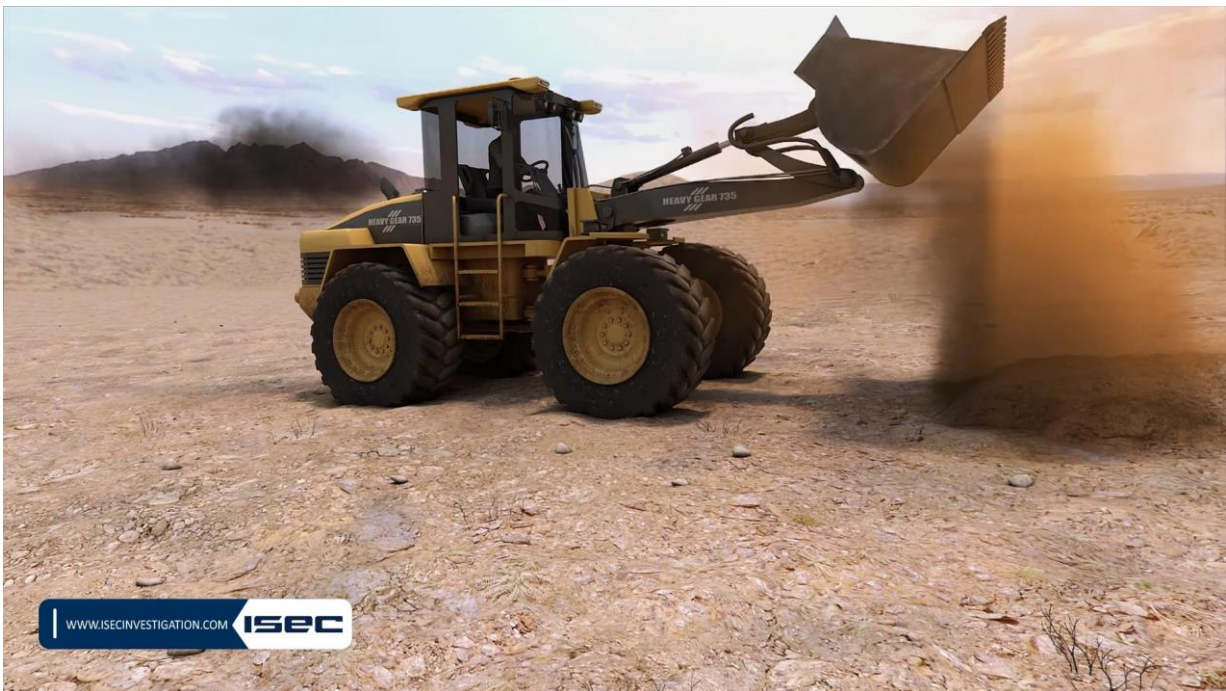
The person went to the location of gas pipes depot alone without informing others and separated three pipes from the rest with the loader bucket to throw a belt around them.

Then he got off the loader and went to the top of the depot pipes and tried to throw the belt around the three pipes, suddenly he slipped on the pipes and loosed his balance and fell between them.

As a result of his slipping and striking the pipes, several pipes moved and one of them which was unstable, shifted and crashed to his back hardly.

The pipe with more than 500 kg weight put a lot of pressure on his belly and chest. He tried to save himself but he didn't succeed.
